Test of 16 1-in PMTs in the pressure vessel with the PMm2 DAQ

Videoconference – Orsay – March 16, 2010

IPNO detector dept.

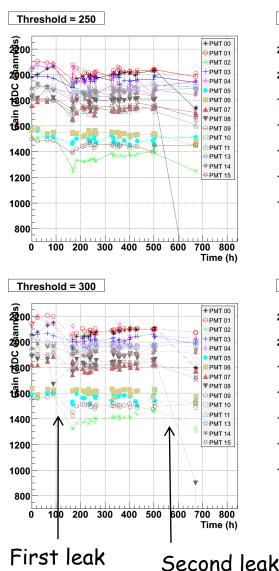
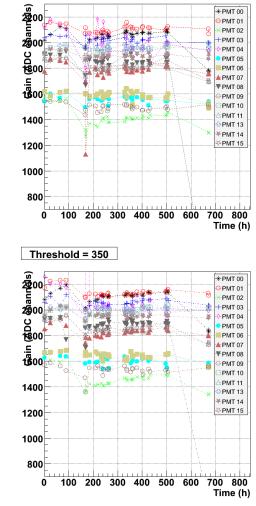
Routine tests: gain

- Change for nearly all tubes after the first light leak
- Followed by a slight increase
 - we don't know whether it is caused by the power supply, bias instability due to a slight water leak, or something else

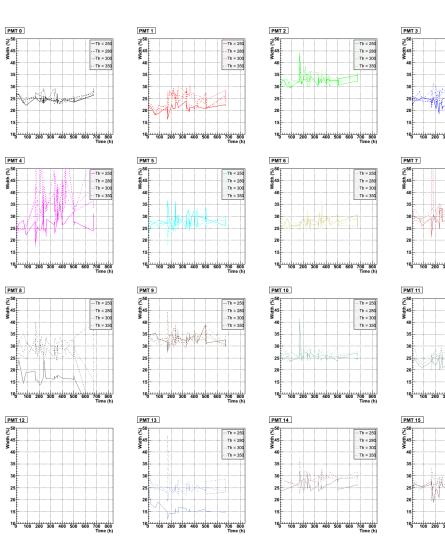
Routine test: width

- Difficulties to fit = peak too large / not enough points
- Rather stable / slight increase, except for PMT#4 and #8

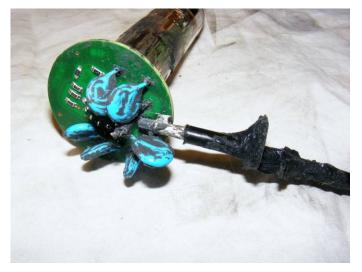
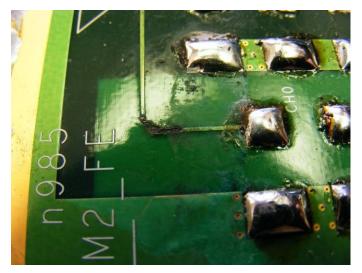
Second water leaks

- Troubles on PMT#8: high counting rate, high voltage does not go above 800 V (short circuit)
- Short circuit due to the water: burns on the PCB!
- More details in T. Nguyen Trung's memo

- Monitor the current (preferably per PMT)
- Monitor the high voltage
- Remote switches on the high voltage, per PMT
