# **Fundamental Power coupler for ESS, experience from series production and conditioning**

Thibault Hamelin

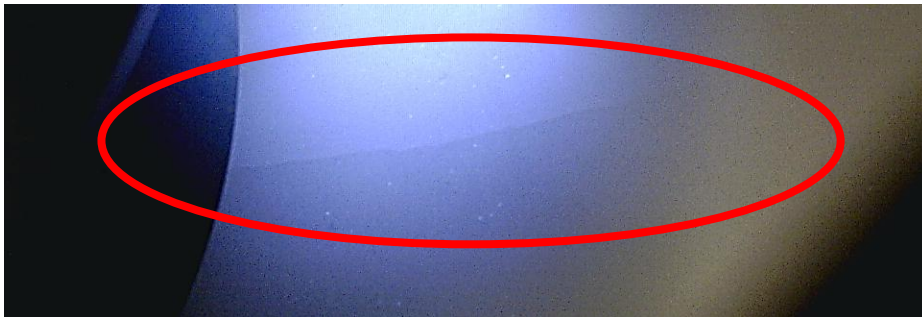
- TiN coating: After the pre-series phase, the TiN coating became too dissipative. This caused window overheating and ceramic cracking during conditioning
  - ⇒ change the subcontractor and made new coating qualification phase (2019)
  - ⇒ add a new temperature criterion for the window
  - ⇒ add a new deposit resistance measurement (multimeter)
- Brazing overflows
  - ⇒ rework using abrasive treatment or reject the parts
- Pieces of ceramic from the brazing spacers trapped in the chokes
  - ⇒ removal of the piece of ceramic

Crack in the ceramic

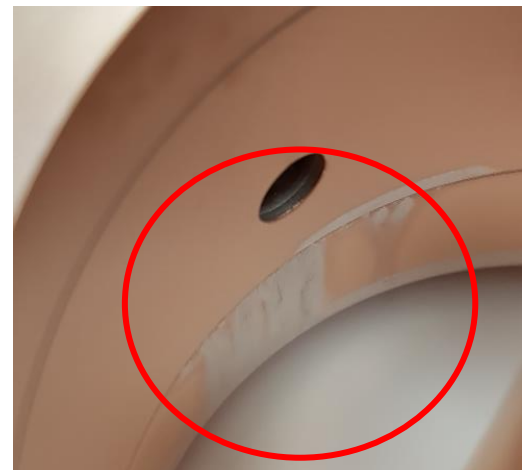
Brazing overflow

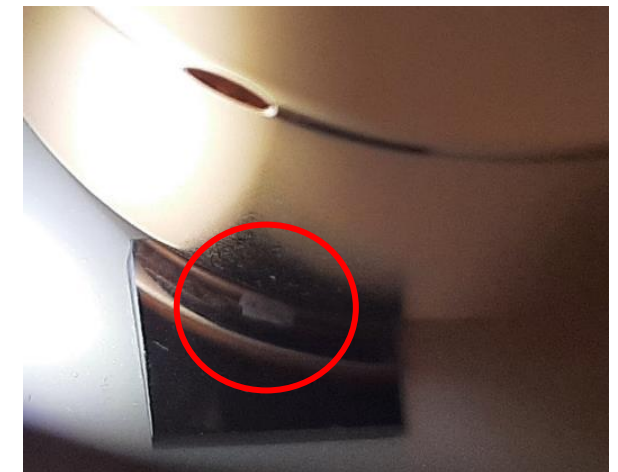
Ceramic fragments

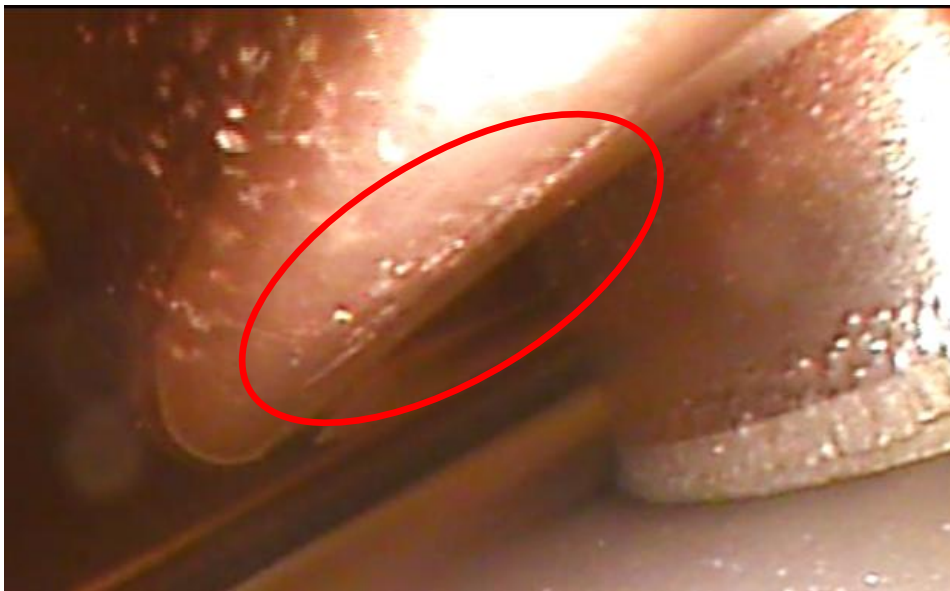
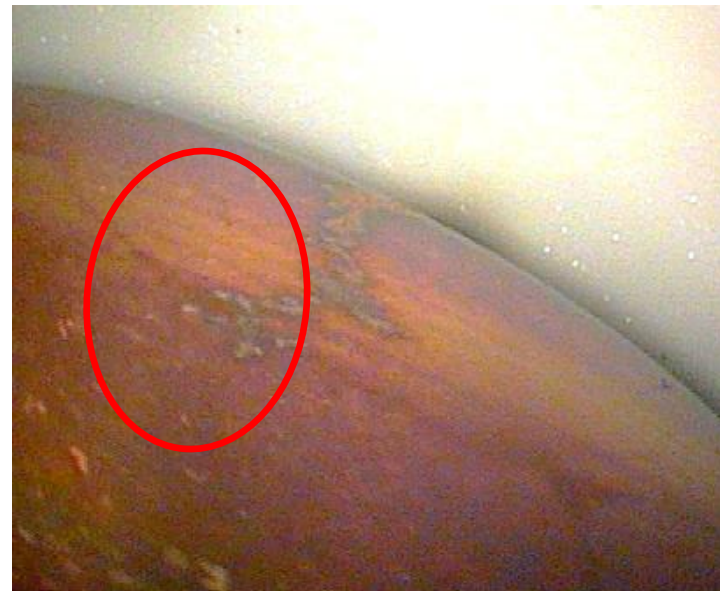
- Main reason is breakdowns:
  - Clearly visible marks
  - Heating area at the brazed joint
  - Deterioration of the copper-plated surfaces
- Reworks using abrasive treatment are then performed. Some windows were successfully conditioned, while others were definitively rejected

Breakdowns marks

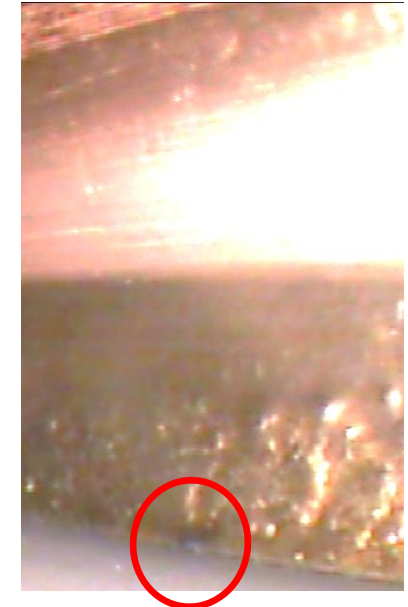
Heating area

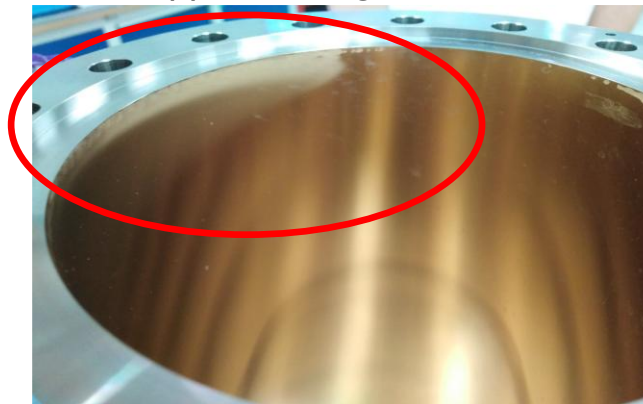
- Copper coating with stains

Copper coating with stains

⇒ stripping the copper plating from the tubes and copper-plated again

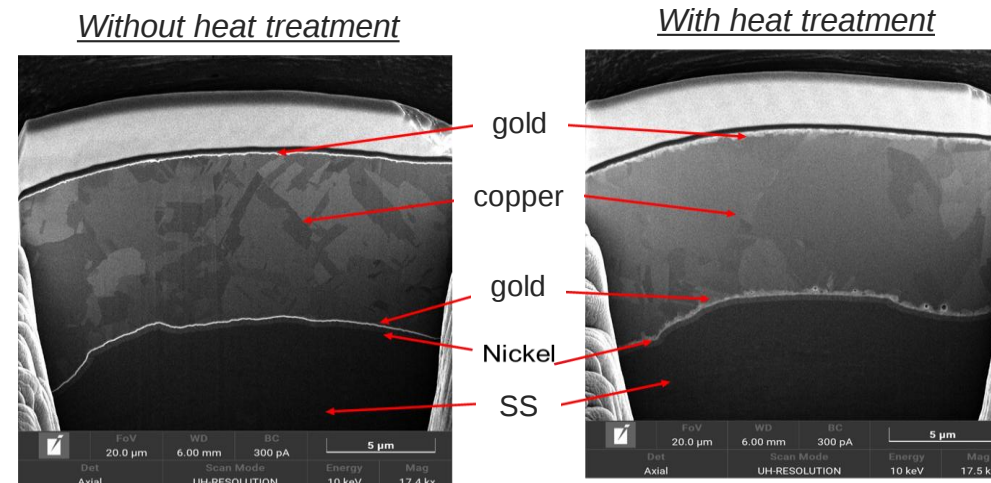
- Generation of electron activity that may cause tube heating } Importance of diagnostics during RF conditioning
- Verification of copper deposits using samples requested during the manufacturing process :
  - Drift in the copper plating process. Presence of an unintended gold flash on the surface
  - Due to operator changes in the coating process

Because of budget limits, we could not continue the investigation and cannot certify that this heating effect was caused by the gold flash coating

→ Or sur couche de Nickel + diffusion des couches d'or

⇒ Anyway the electronic activity disappears with RF conditioning but increase the conditioning time
