# PIP-II SRF Couplers: Fabrication Status and Addressing Ceramic Yield Challenges

**Tommaso Aiazzi**

# Ceramic Window Failures – Vendor 1

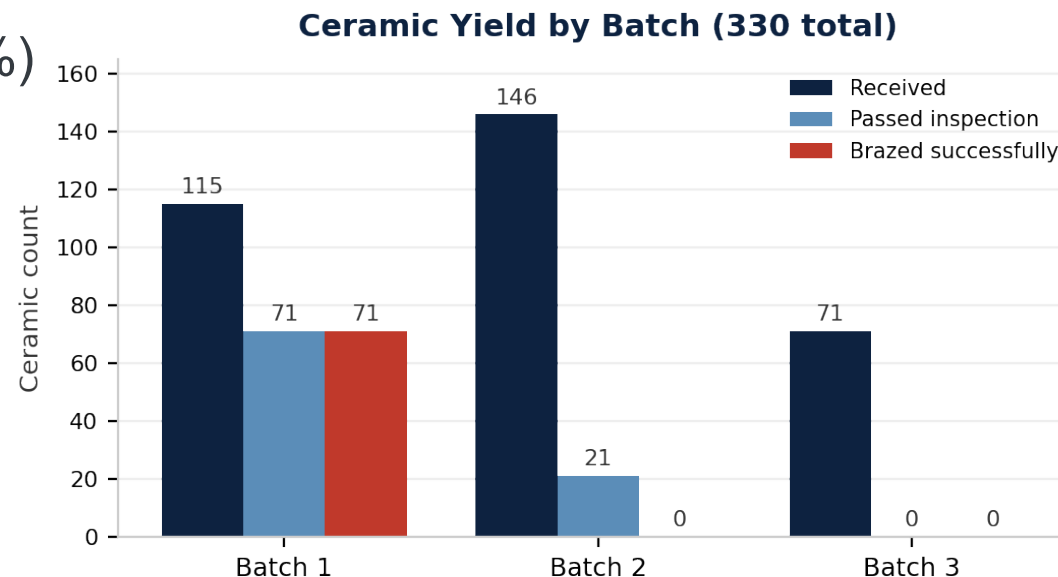
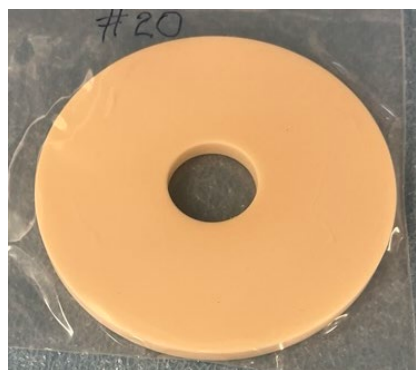
Base ceramic disk

Leaks at the ceramic-to-metal braze interface

- 115 received, 71 passed inspection, 100% yield in brazing
- 146 received, 21 passed inspection, 0% yield in brazing
- 71 received, 0 passed inspection

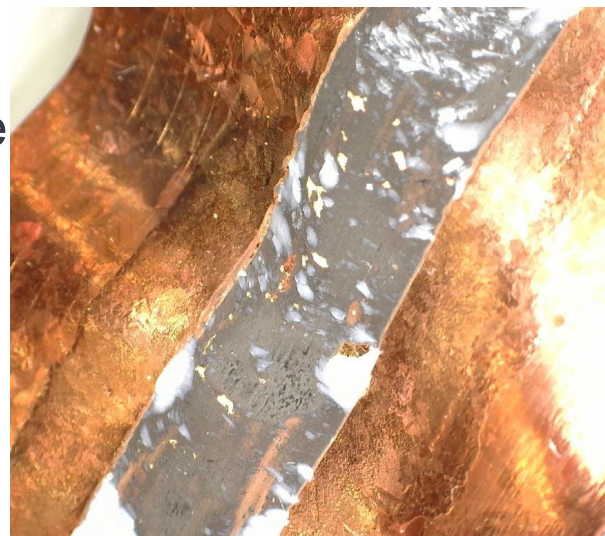
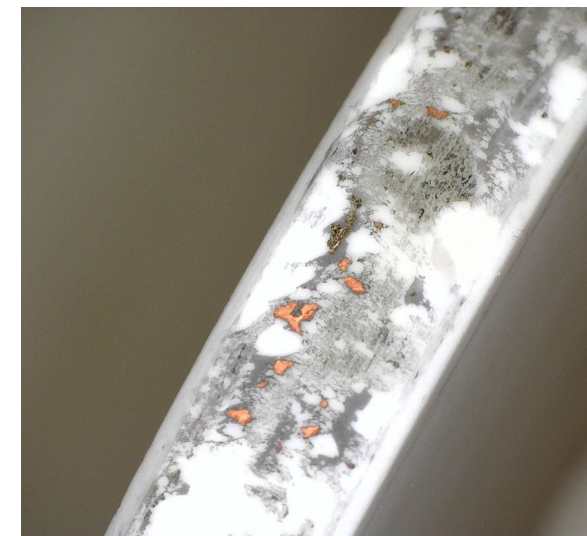
Peel tests

- Changed vendor due to high rejection rate
- Same specification used to order and all the ceramics went through the same inspection process
- 24 out of 60 received passed inspection
- 0% yield on brazing
- A peel test was done to assess the brazing, showed that the adhesion and strength was very good on a global basis, but the uniformity was very nonuniform across the sealing surface
- Test on density and grain size were also done and didn't show any non-conformities

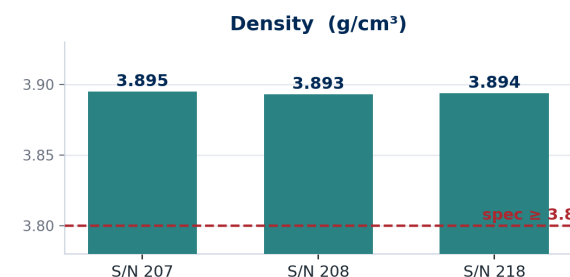
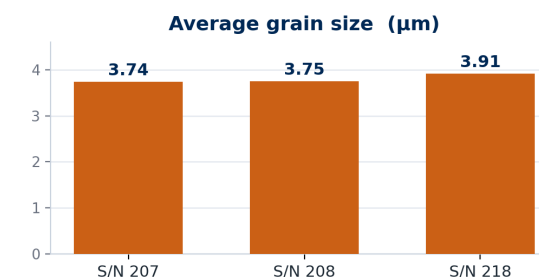
## Bare-ceramic inspection — 3 units (Kyocera)

All dimensions, density and grain size within spec — **the ceramic conforms; the failure is in the braze.**

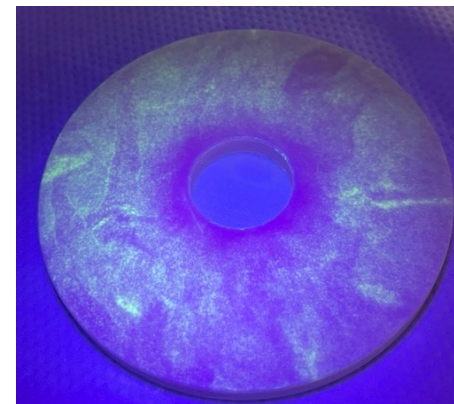
fail

- ZL-4C penetrant, 10 min dwell
- Rinse, then ZP-4D developer, 10 min
- UV inspection of all surfaces for cracks
- Any indication  $\rightarrow$  reject

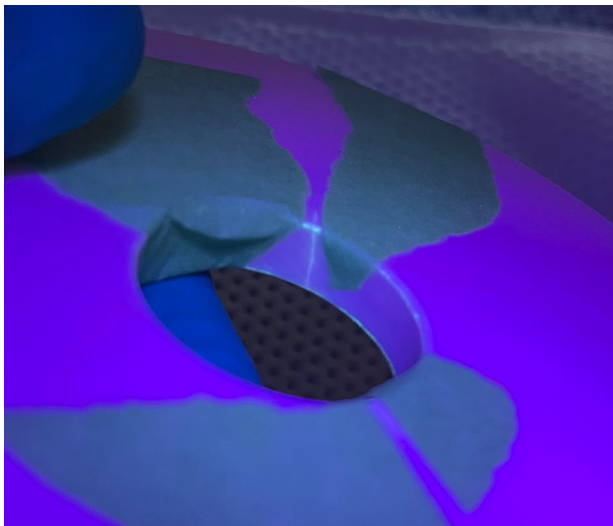
Dye penetrant under UV

Suspect cracks are confirmed by dye penetrant under UV, then mapped optically and at the surface by SEM.

**Toughness check:** we tried to fail a good disc on purpose. Deep diamond-point scribes followed by wrench blows produced no cracking or chipping. The bulk alumina is far tougher than the failures suggest, pointing to the braze joint, not the ceramic, as the crack origin.
