Progress Report

2015.11.12

Dish Antenna

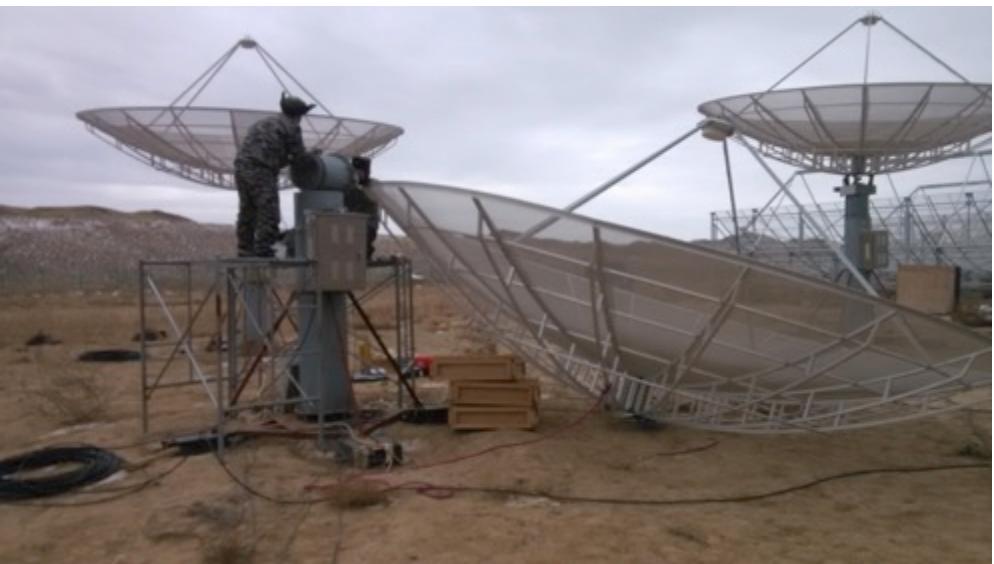
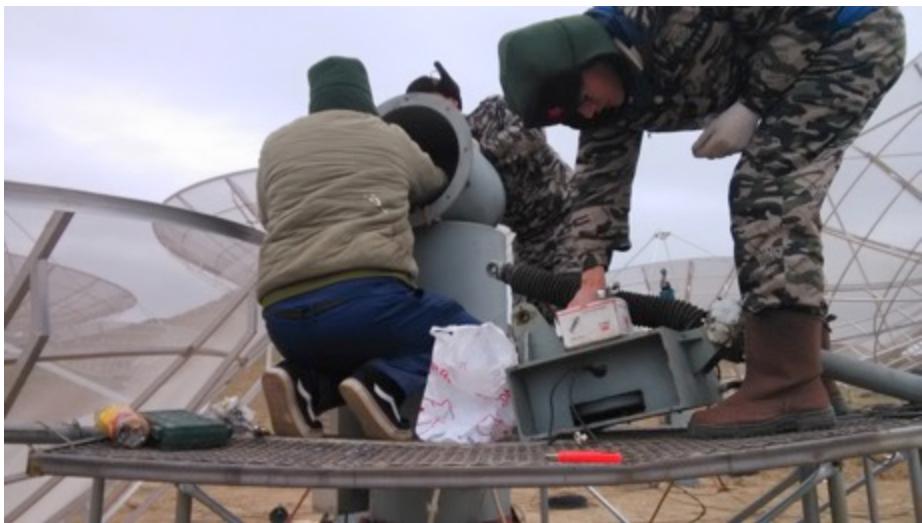
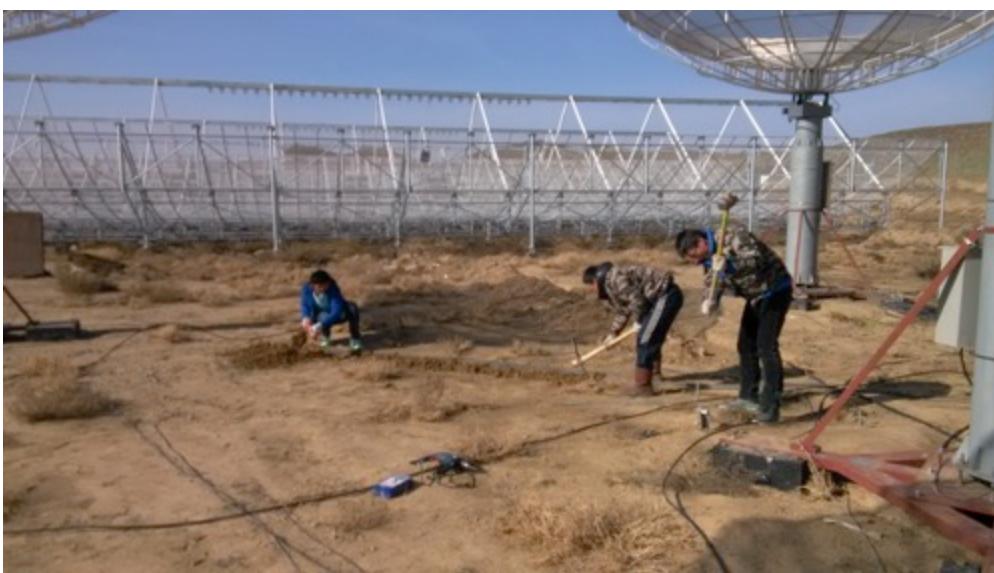
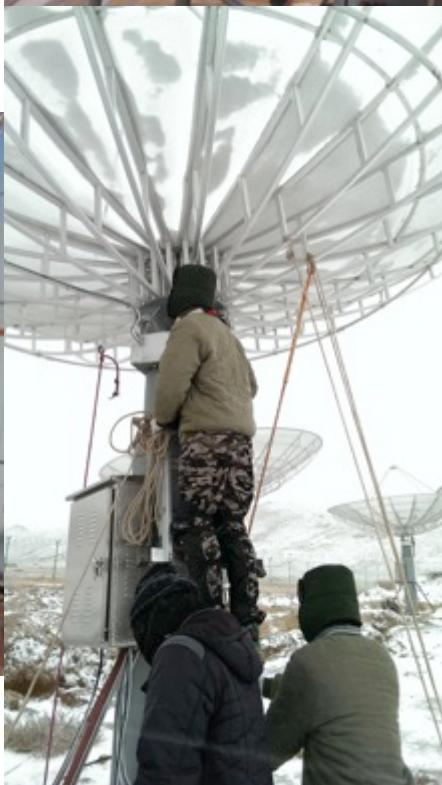
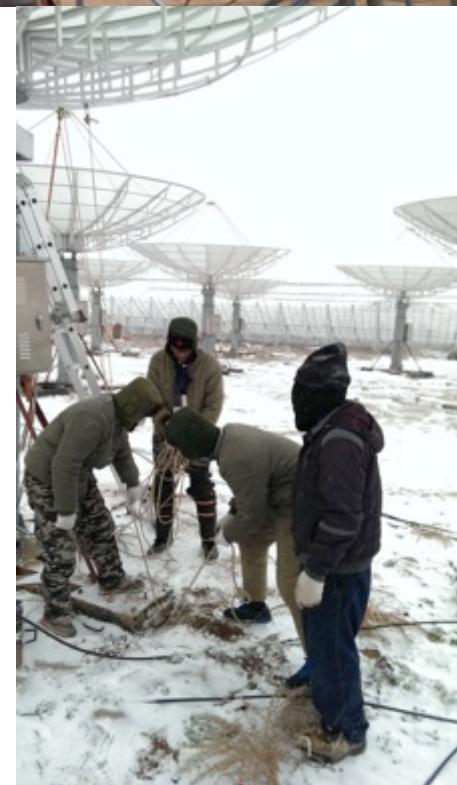
- Many antenna exhibit sloshing. Initially the engineer from the manufacture thought it is normal and would get better after break-in period, but it seems to get worse.
- Now we think it is due to the two opposite bolts on one line are too long and blocking each other, so that it can not be really fastened. These two bolts are now replaced with one single long bolt. The antenna are being fixed at a rate of two per day. Now most have been fixed.
- Underground power cable installed
- Some circuit boards are damaged, probably due to lightning.

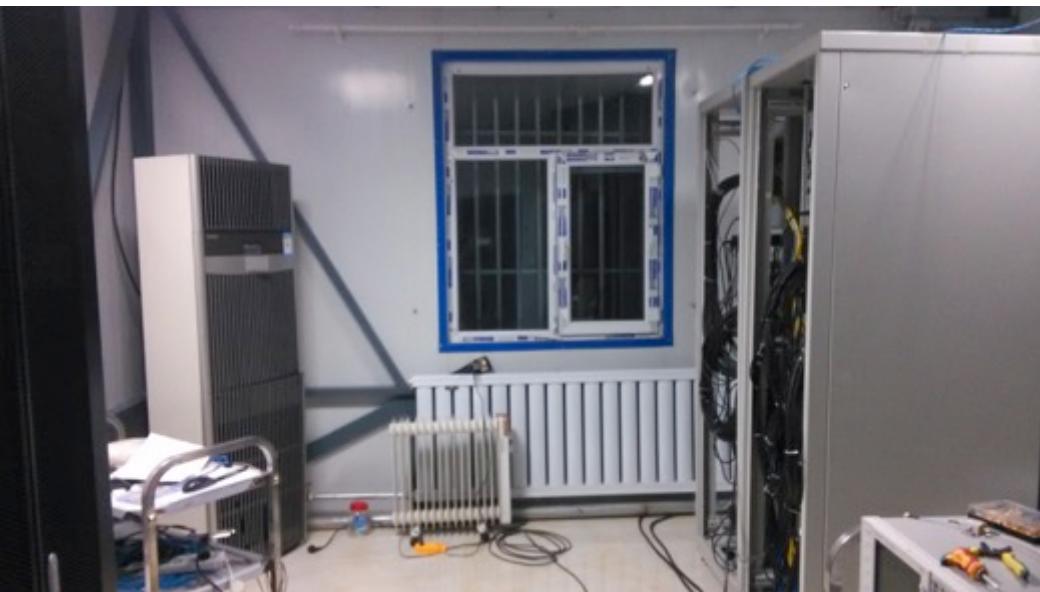
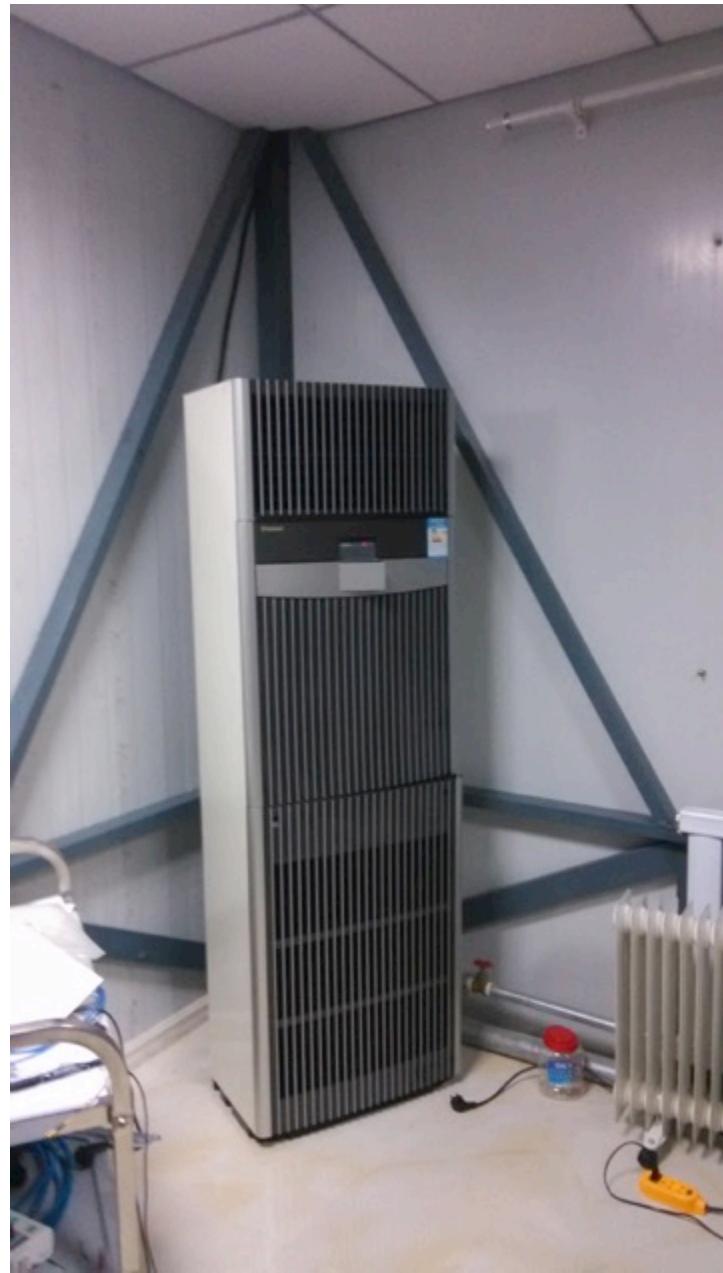
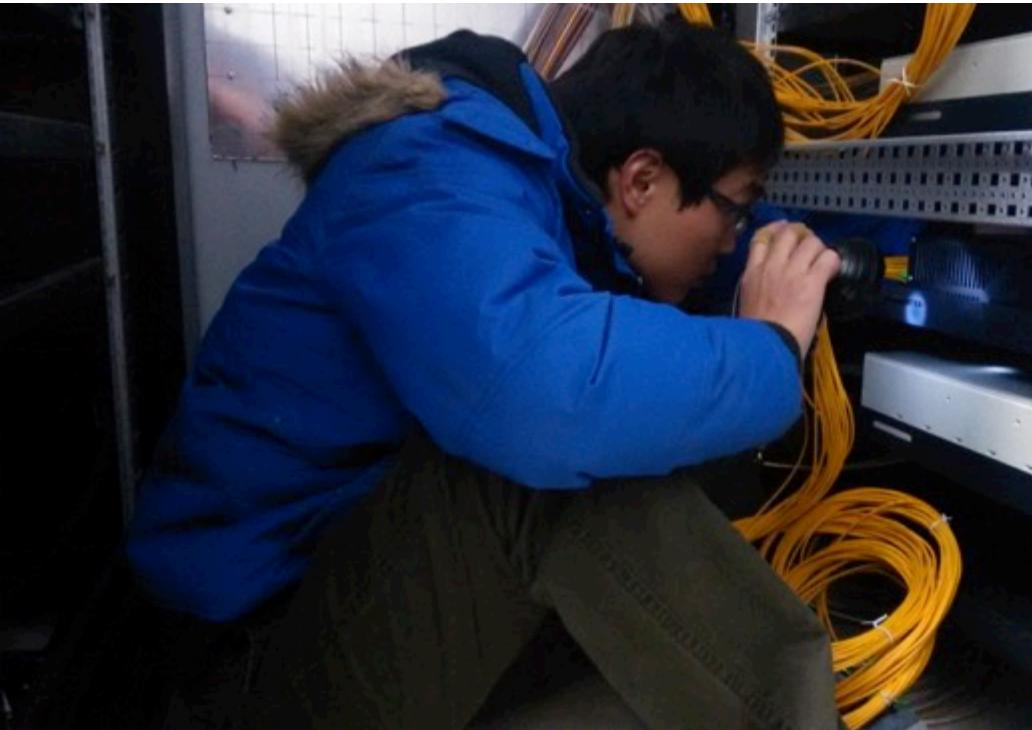
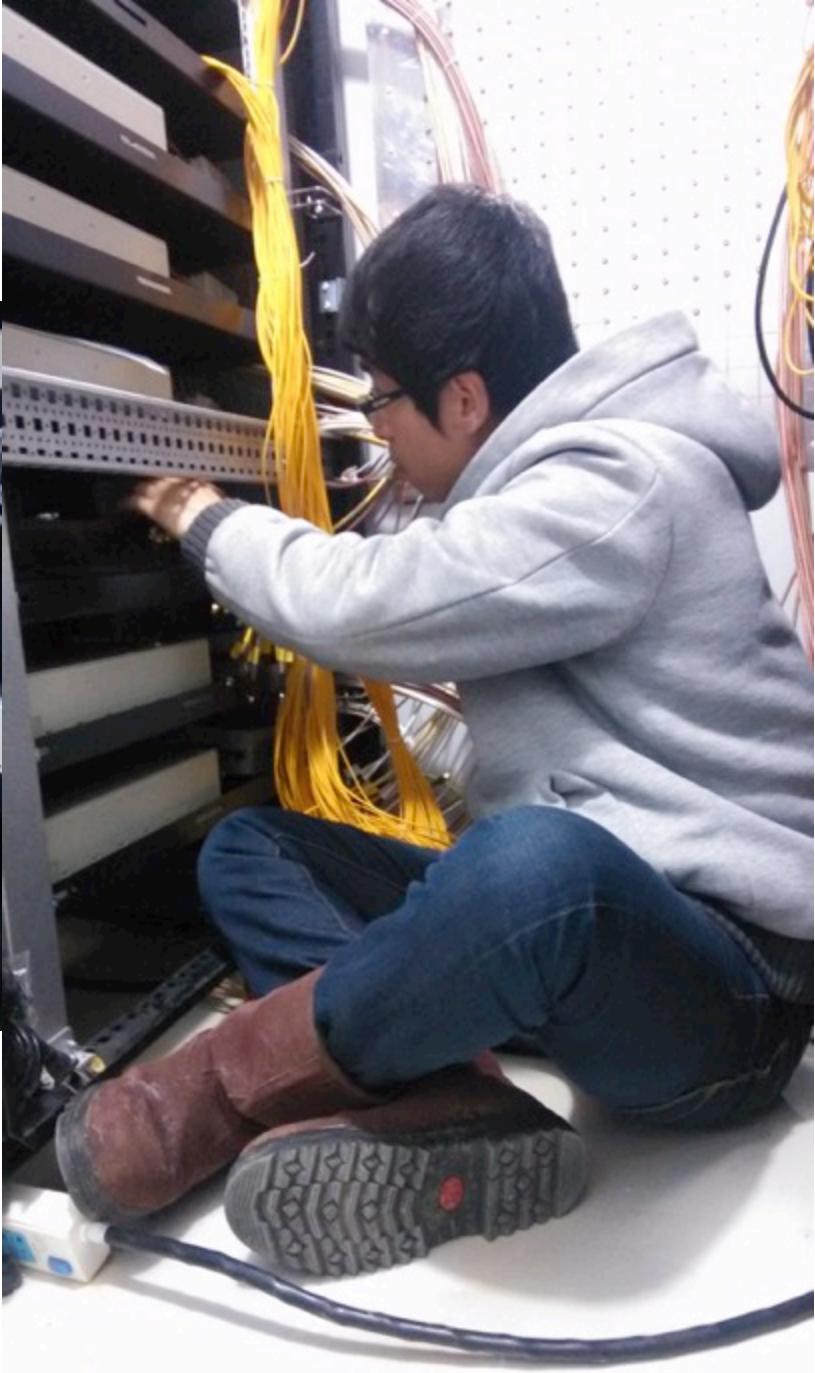
- Correlator shipped and installed, lines connected
- 2 circuit boards (16 inputs) damaged, being replaced.
- Now output every 5 seconds. Theoretically now it can do 2 seconds output. Need to improve the data rate.
- A high power Air Conditioner installed.
- Room too small, and too much dust. May need re-arrange next year. Shipping container?
