# Noise?

Martin Schimassek

# What do we mean with noise?

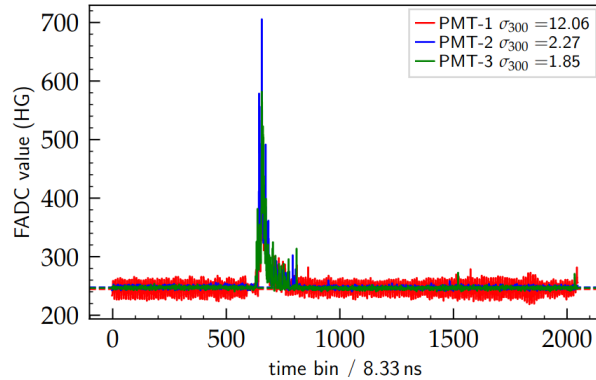
station 1261 from event 73090362

- Observe significant tail of pedestal fluctuations in trace data affecting ~20% of PMTs

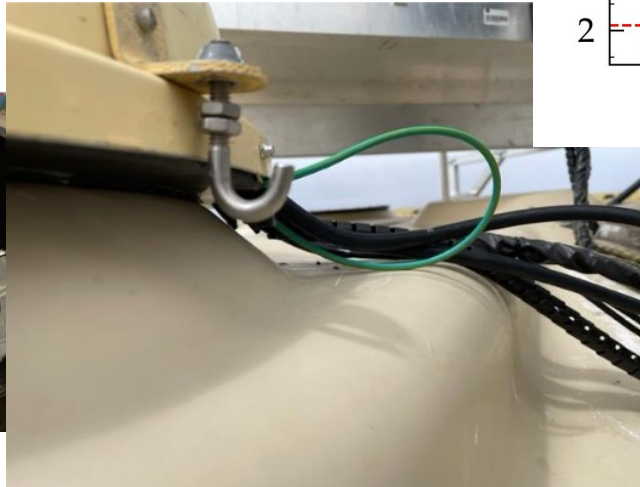
Figure 3: Grounding cable loop in The Nameless PhD

- field campaign (Corine, Antonella, Juan Pablo, Patrick, Tiina) during Malargüe meeting:  
visit selected stations (1499, 1415, 1515, 1494) with PMT-1 noise to check cabling

- several problems with cabling identified

→ comparison of noise levels before / after  
shows clear reduction

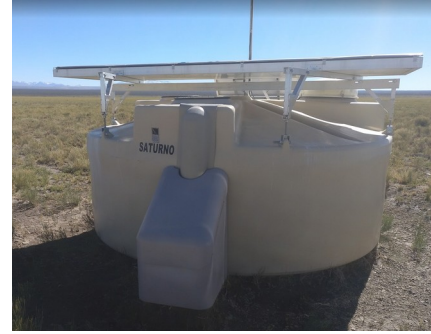
Saturno (1093)  
- SSD-cable  
- sPMT-cable  
- grounding rod

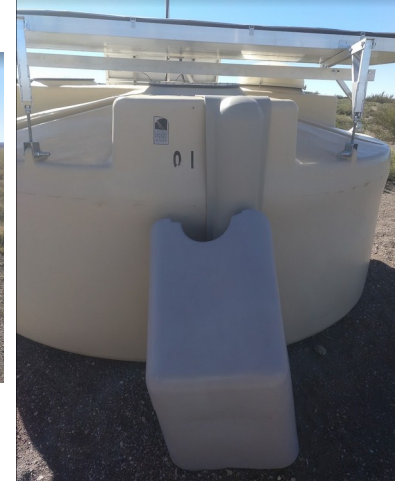
J.W. Cronin (1097)  
- SSD-cable  
- sPMT-cable

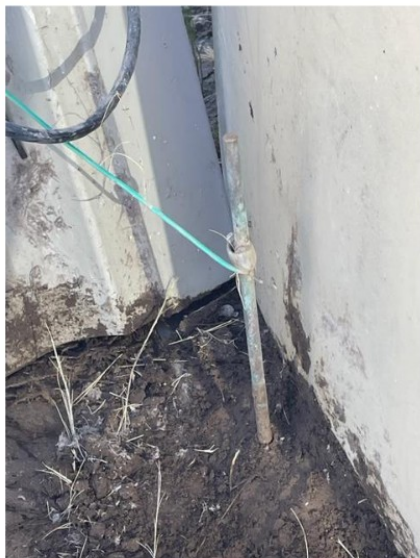
Figure 3: Grounding rod behind the battery box of Saturno.

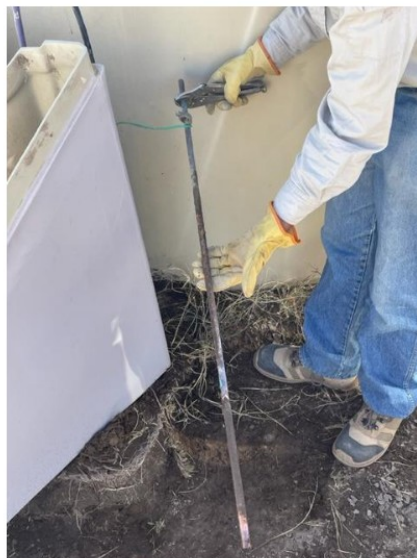
Figure 4 : Grounding rod in Saturno.

New rod @ Saturno

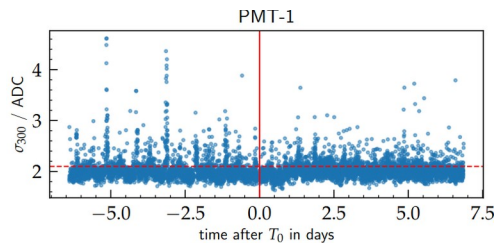
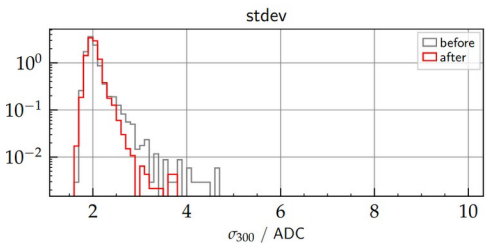
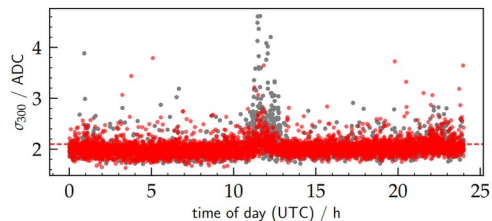
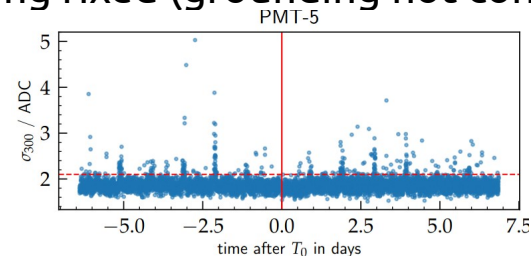
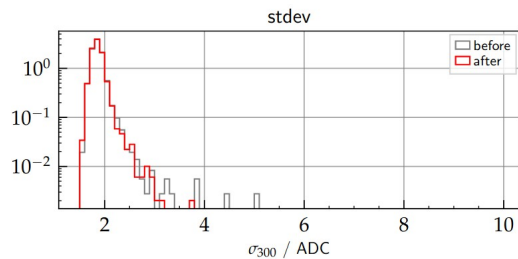
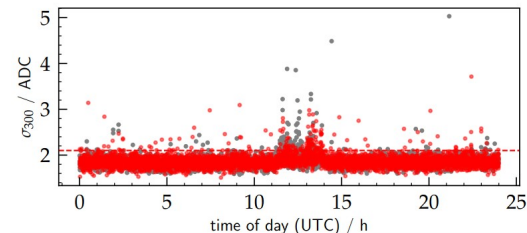
- intervention at Constanza (734) [report → Ioana]: cabling fixed (grounding not connected)

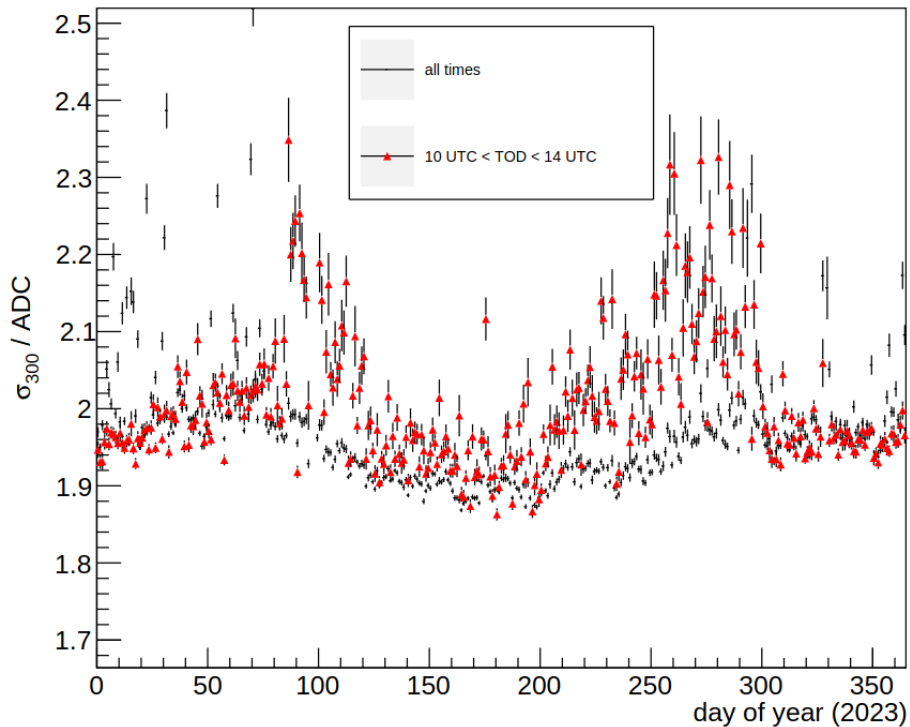
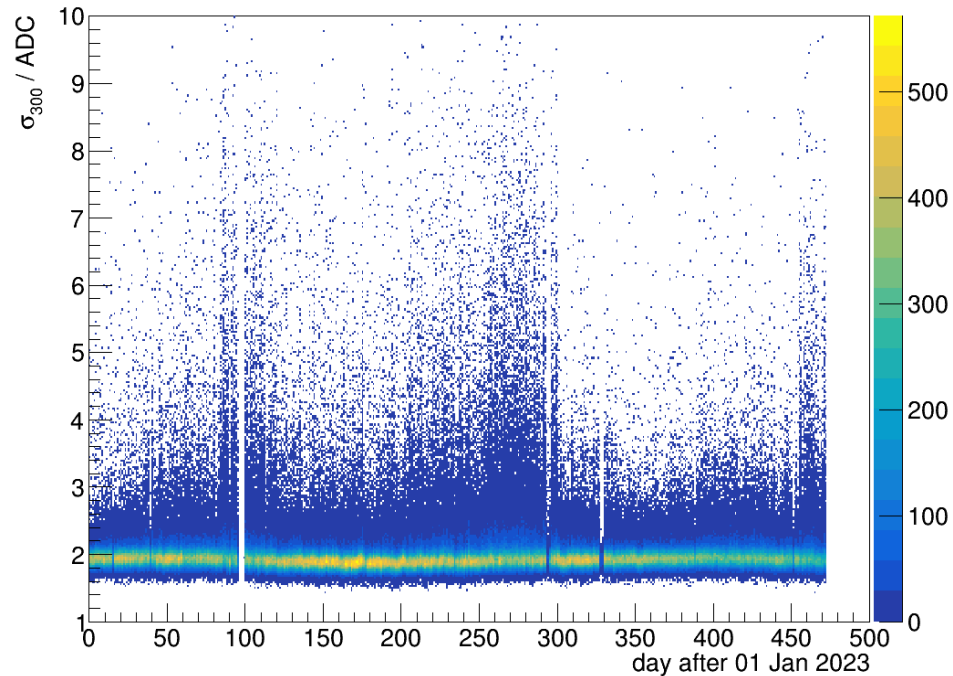
- how does the noise behave on long time scales?
- do we see the seasonality we had in ToTd?

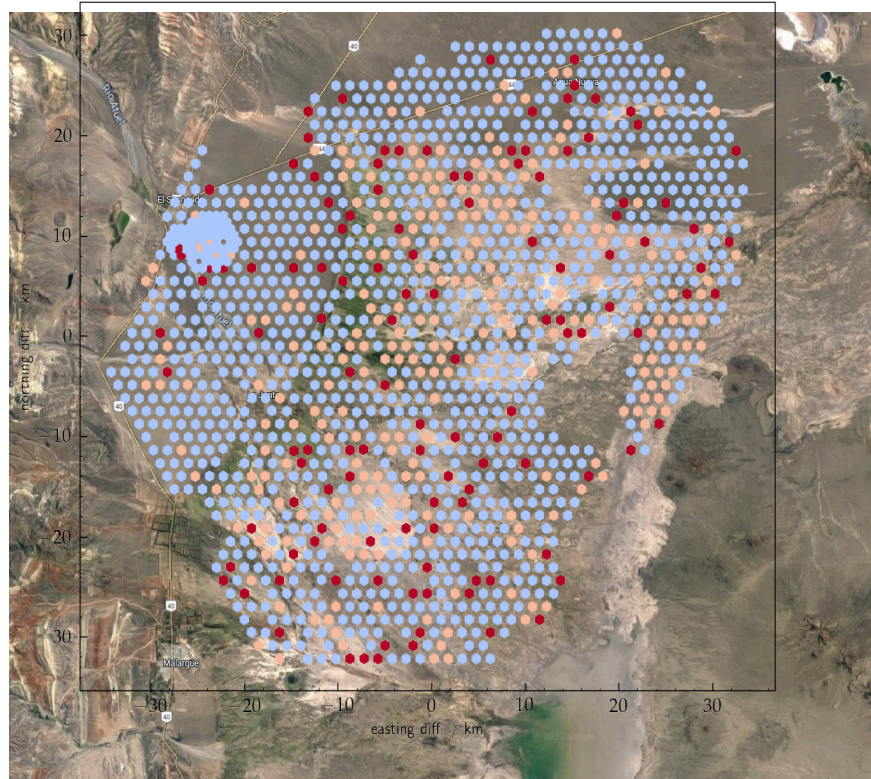
- we see a 'visual' correlation of noise problems with ground type (c.f. SDEU 19.09.2023)

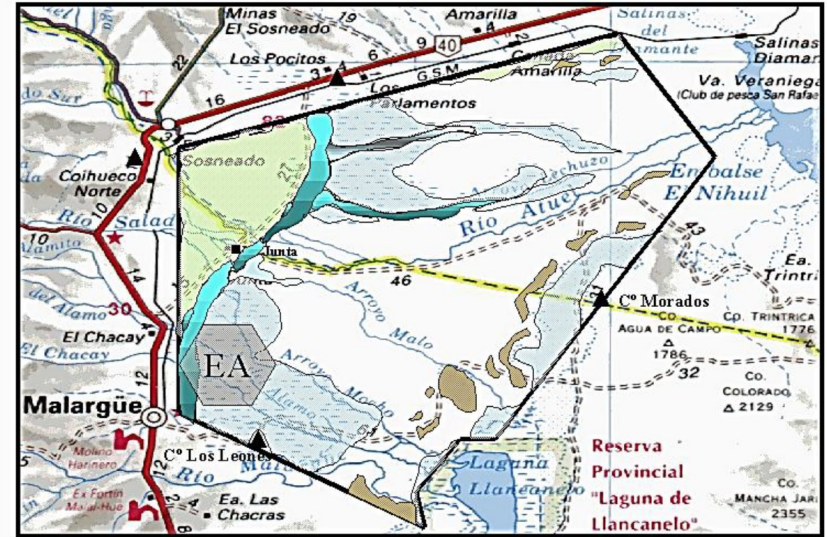
## Sketch of the site soils distributions

- Fine grained sand.** Dunes (frequently not linked one another) resting on silty soils, scarce vegetation.
- Silty with clay** Boggy lands with small lagoons in winter, dense bushes "cortaderas".
- Silty with clay** Dry and soft soils, scarcely bushed area (mainly without thorns), difficult to pass after rain/snow.
- Mainly gravel and sand.** Wet and salty soils, not passable after heavy rains and hydrological rich years.
- Mainly gravel and sand.** Alluvial cones and alluvial terrace, passable all year (bushes with dangerous thorns).

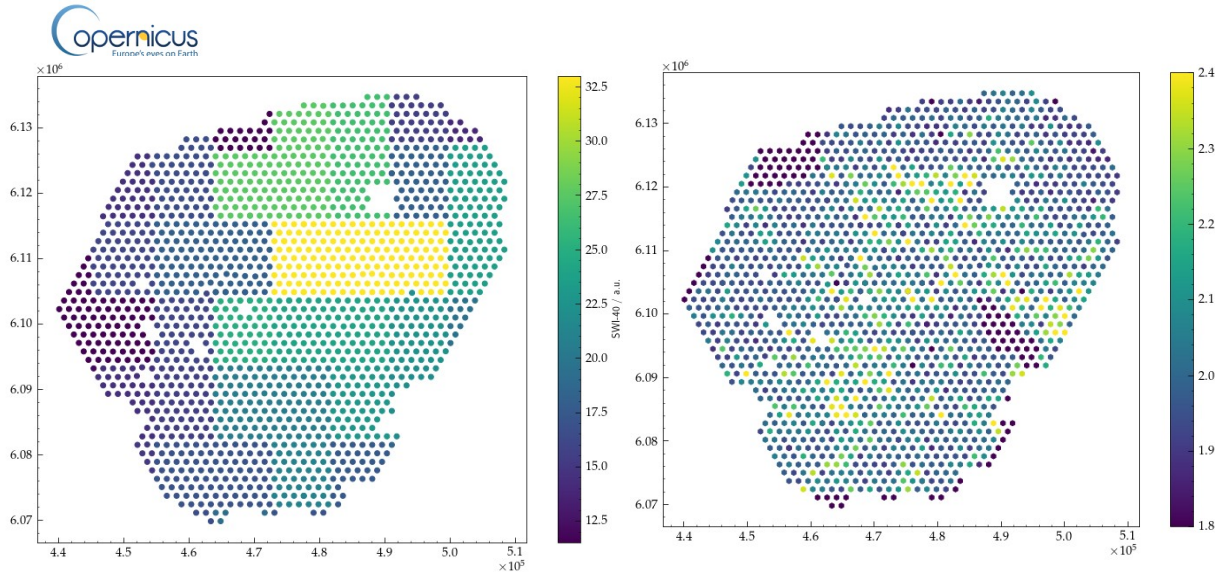
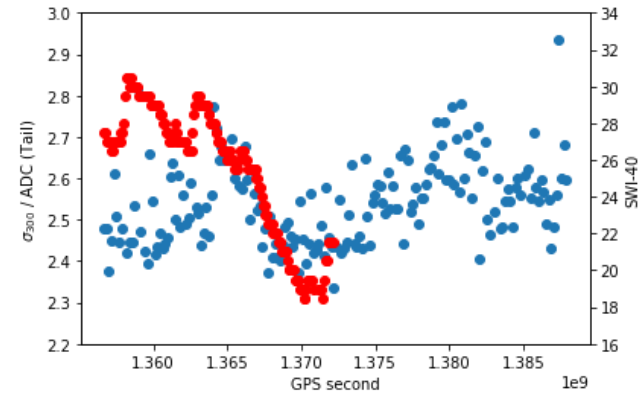
- we see also a correlation with soil-water index (SWI) [provided by F. Frau (Istituto National del Agua)]
- in timeline the correlation is only present in parts of the year, so maybe just an accidental correlation but hinting towards grounding issues?

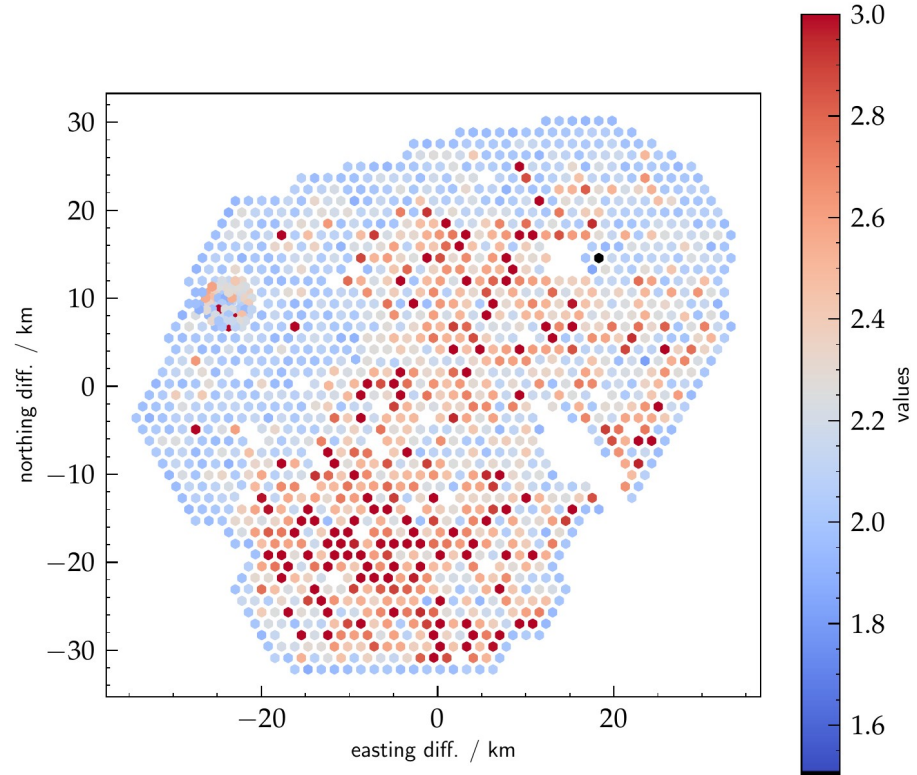
- use May 2024 data (from the tutorial)
