# Issues and mitigation methods with FPC during 1.3GHz Cryomodule assembly

**Institute of Advanced Light Source Facilities, Shenzhen**

**09-12 June, TTC'2026 Meeting, Paris Saclay**

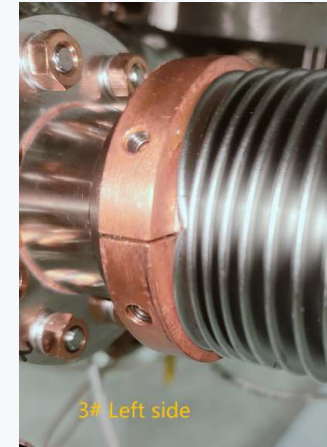
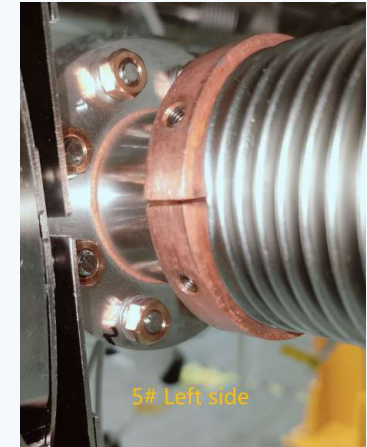
1. Change the connection way between copper braid and 5K thermal shield
2. Severe deformation on cold end coupler bellows were found, especially on FPC 2#, 3#, 5#
3. The 5K thermal shields were torqued to  $7.4\text{N}\cdot\text{m}$ , no experiments before assembly.

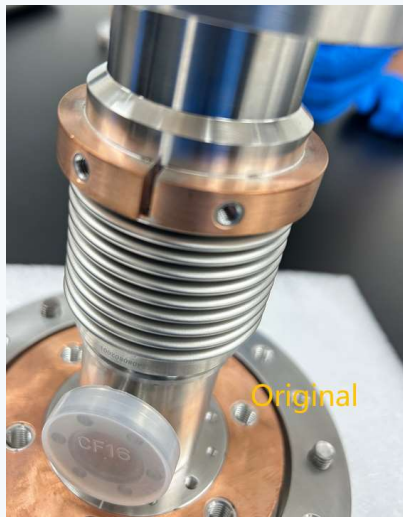
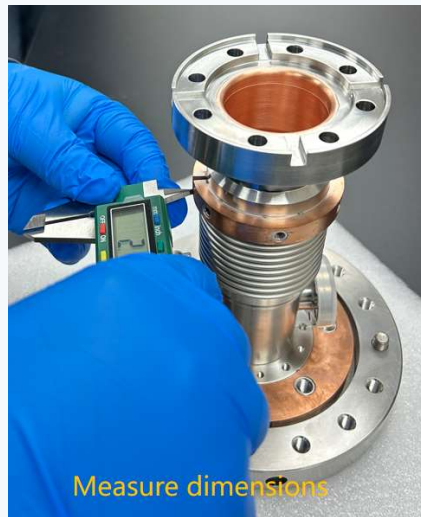
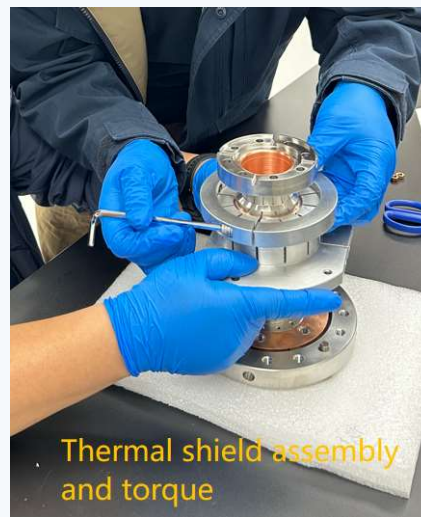
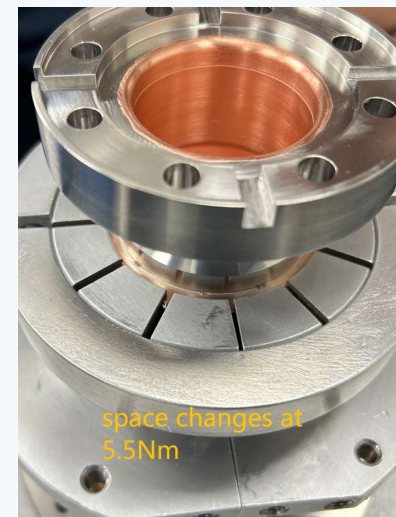
4. Carry torque application test on a new AIR cold end coupler bellow, torque ranges from  $2.5\text{N}\cdot\text{m}$  to  $10\text{N}\cdot\text{m}$ , no severe deformation occurred.
5. The space of 5K thermal shield pins changes significantly from torque  $5.5\text{N}\cdot\text{m}$ . Even there is no severe deformation, obvious protrusion appears on the inner bellows due to the squeezing effect of  $8.5\text{N}\cdot\text{m}$ .

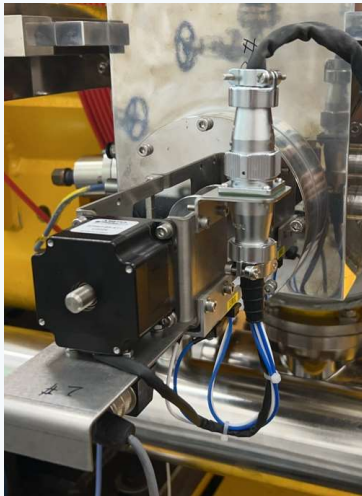
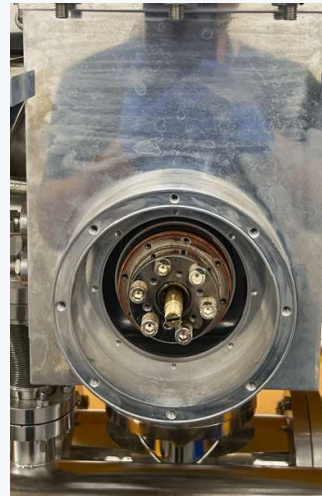
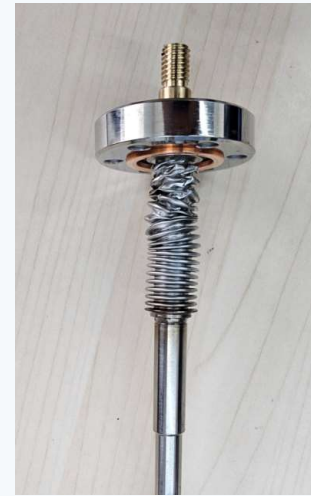
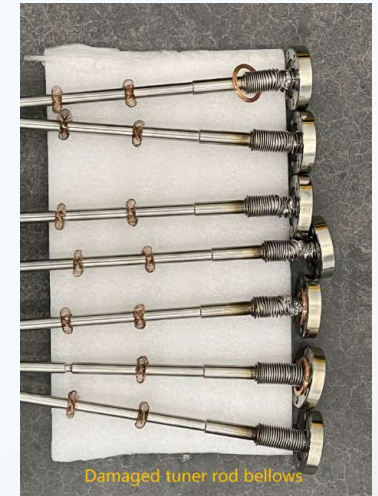
1. Before coupler drive motors installation, warm coupler vacuum was OK and the ion pump was on.
2. After motors connected to brass connectors, we found the ion pump stopped automatically, and the vacuum pressure rised sharply to  $10^4\text{Pa}$ .
3. At last, 7 out of 8 tuning rod bellows were found damaged, indicating a high failure rate likely due to brass connector rotating during the motors installation.
