Test of 16 1-in PMTs in the pressure vessel with the PMm2 DAQ

Videoconference – Orsay – March 16, 2010

IPNO detector dept.

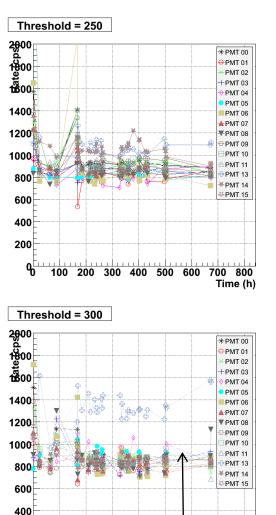
Routine tests: rate

- First detected by an increase of the counting rate, then by an absence of single electron peak.
- First: troubles with the enclosure joint. Replaced.
- Suspected troubles in the pressure vessel's water tighness. Corrected
