Progress Report

2015.11.12

Dish Antenna

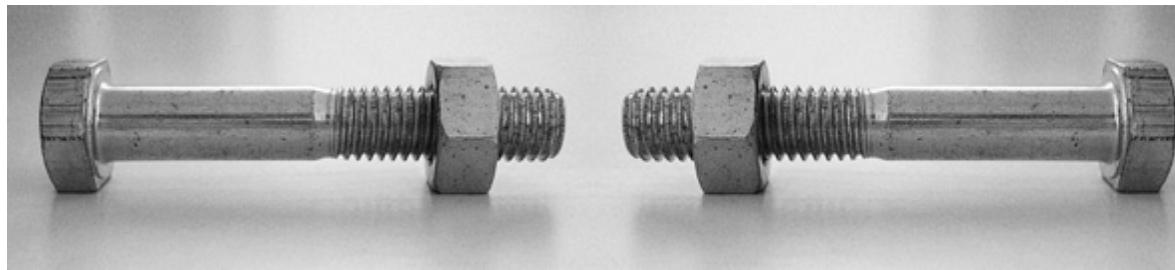
- Many antenna exhibit sloshing. Initially the engineer from the manufacture thought it is normal and would get better after break-in period, but it seems to get worse.
- Now we think it is due to the two opposite bolts on one line are too long and blocking each other, so that it can not be really fastened. These two bolts are now replaced with one single long bolt. The antenna are being fixed at a rate of two per day. Now most have been fixed.
- Underground power cable installed
- Some circuit boards are damaged, probably due to lightning.
